**REBAR PLACEMENT  
ILLUSTRATION**

<b>CITY OF BANNING</b>
	<b>BUILDING DEPARTMENT</b>
<b>FREESTANDING BLOCK WALL</b>	
(951) 922-3120	99 E RAMSEY ST - BANNING CA, 92220
Fax (951) 922-3128	12/27/2006   BANGARDENWALLFNL.VSD   PAGE 2 OF 2

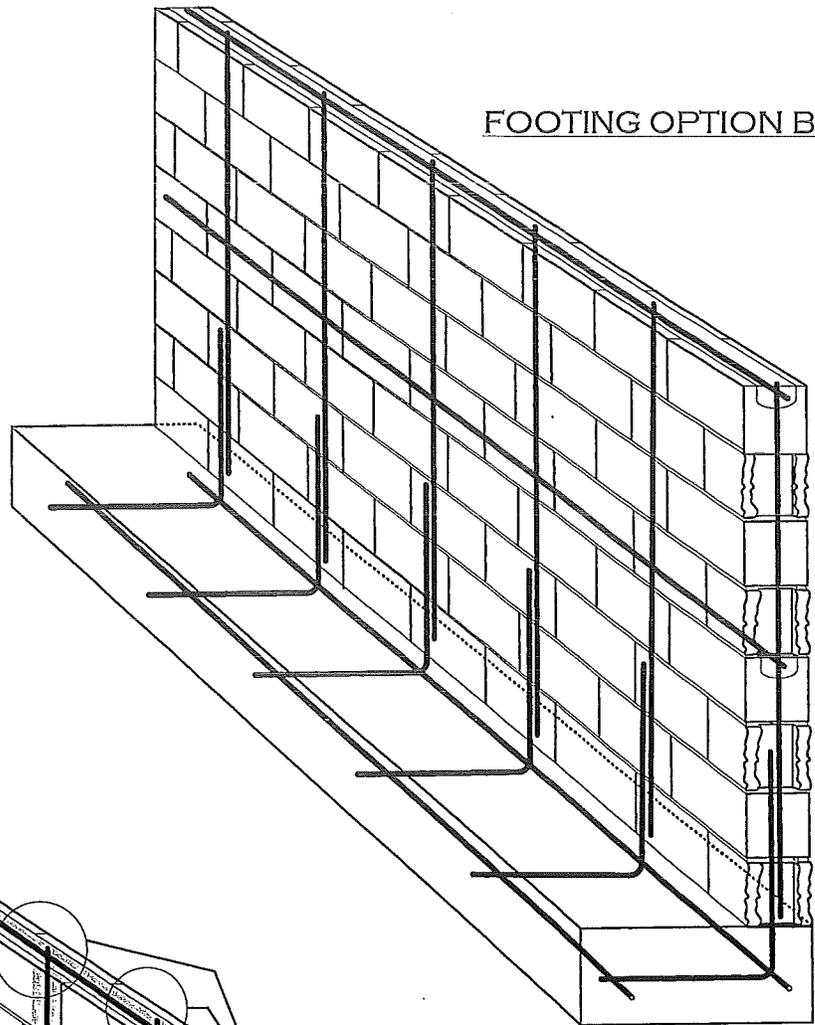
**FOOTING OPTION B**

(TYPICAL)  
ALL REBAR SPLICES  
24" MIN. OVERLAP

(TYPICAL)  
ONLY CELLS AND BOND BEAM  
COURSES WITH REBAR TO BE  
GROUTED  
(DO NOT SOLID GROUT ENTIRE WALL - USE  
GROUT STOP MESH AS APPROPRIATE)

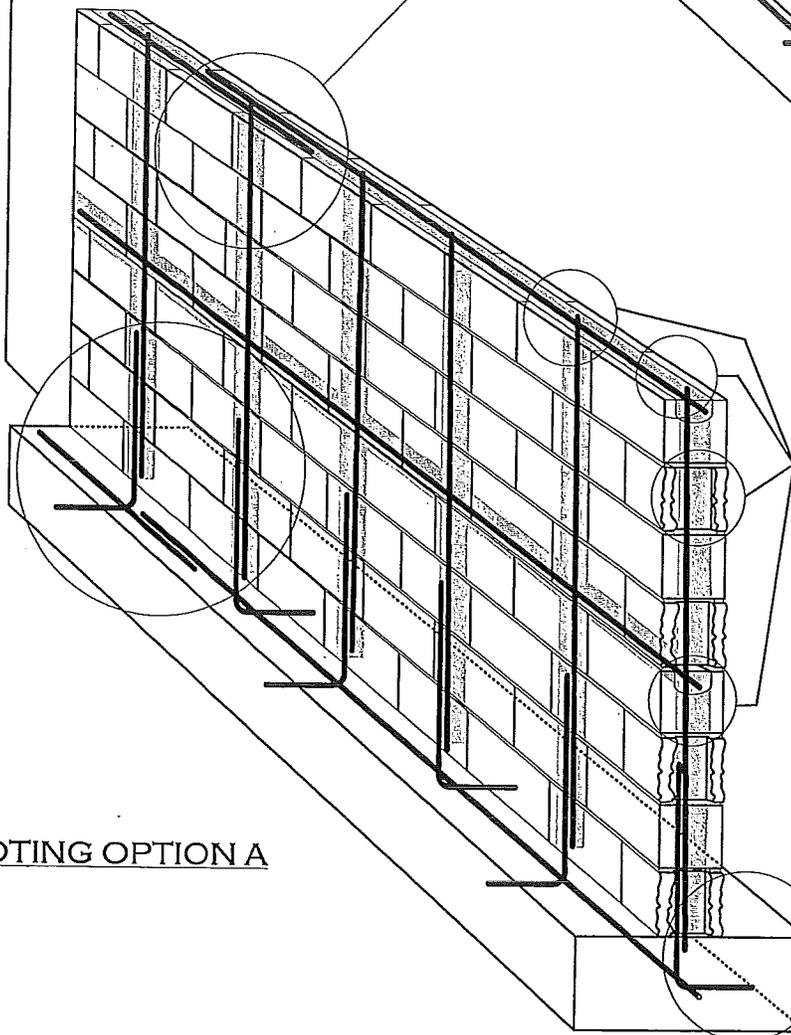
**FOOTING OPTION A**

(TYPICAL)  
ALL REBAR SHALL HAVE A  
MINIMUM OF 3" CONCRETE  
COVER AT FOOTINGS

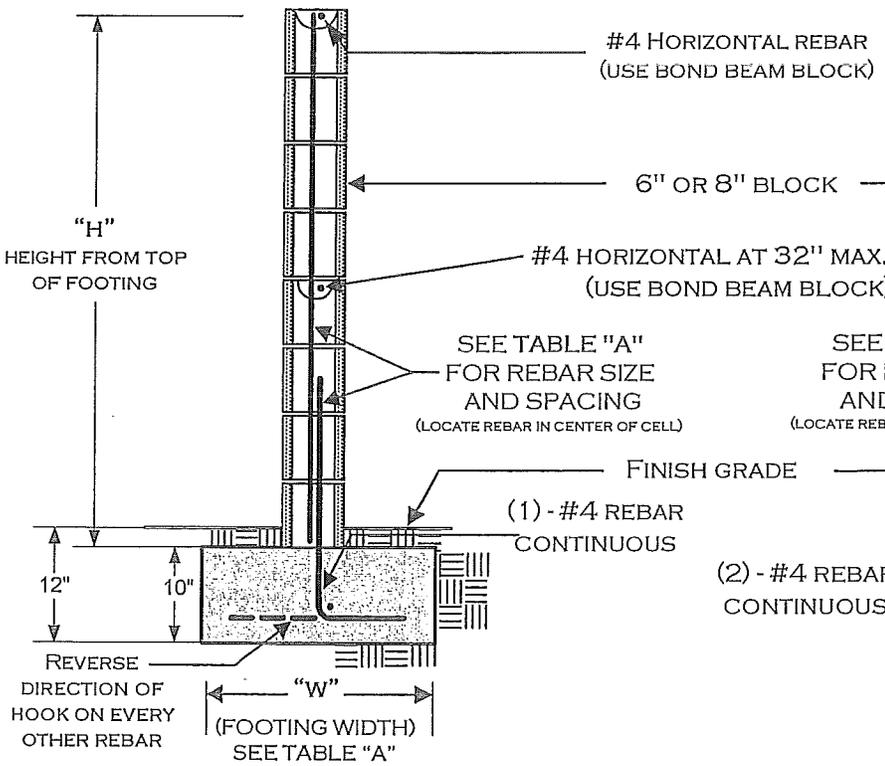
## FOOTING OPTION "A"

"H"	"W"	VERTICAL REINFORCEMENT
3'	17"	#4 @ 48" O.C.
4'	20"	#4 @ 48" O.C.
5'	23"	#4 @ 48" O.C.
6'	29"	#4 @ 24" O.C.

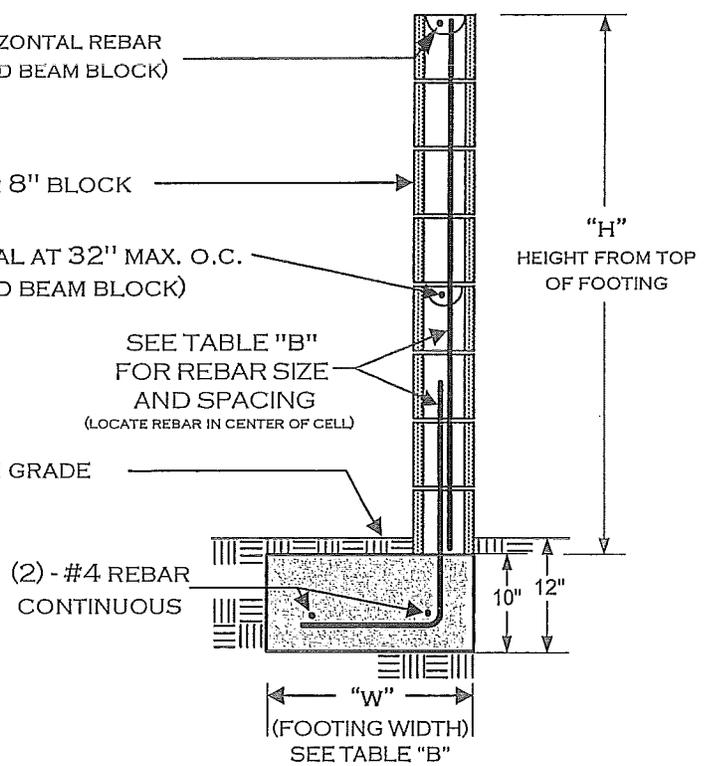
## FOOTING OPTION "B"

"H"	"W"	VERTICAL REINFORCEMENT
3'	19"	#4 @ 48" O.C.
4'	22"	#4 @ 48" O.C.
5'	29"	#4 @ 48" O.C.
6'	34"	#4 @ 24" O.C.
